# Hardware Notebook

Week by week, 23 March to 17 October 2026

A record of the hardware we built for ReLEAF, one week at a time. Nine things got made: a humidity box, an agar plate imaging station, two vertical agar stands, a hydroponic floating plate, an in-line photometer and a simplified one, the light plate apparatus (LPA, called DiOPAL until October), and the bioreactor.

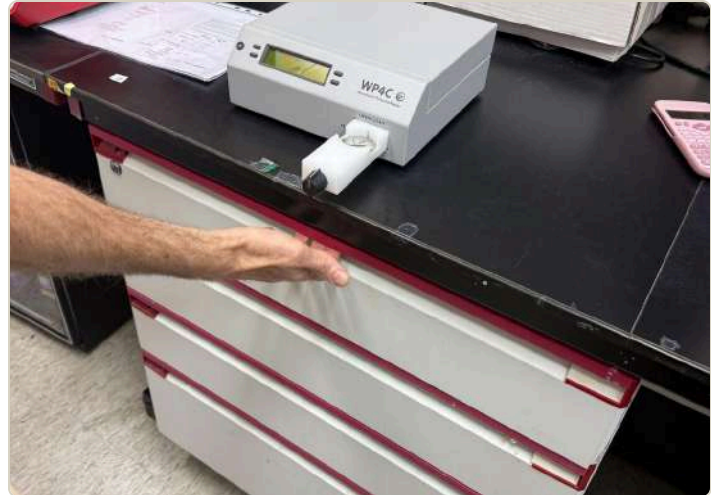
Photometer we saw at his lab that measures cell density

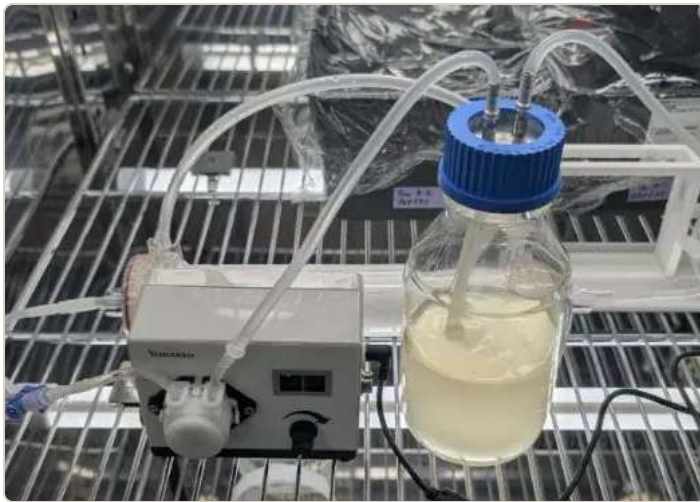
Prototype I loop on the bench: pump, membrane cartridge, reservoir

- **Terminated early when medium leaked at the peristaltic pump.**

- The leak was at the pump head, where the tubing flexes most.

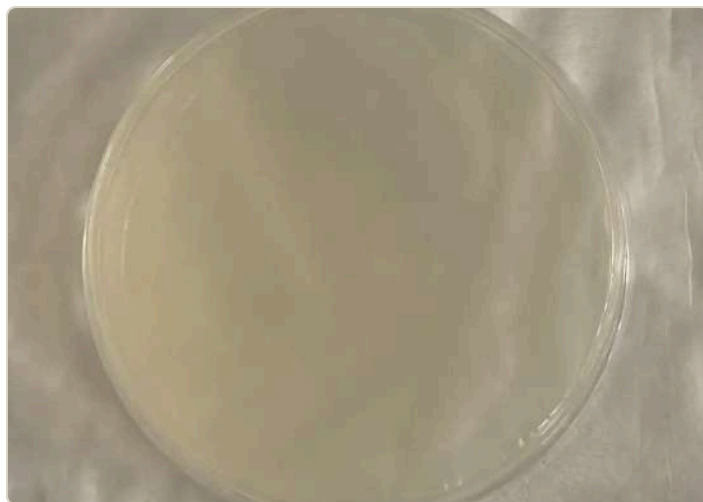
- That is our evidence the membrane holds the bacteria in. It came out of the run that otherwise failed.

Shell-side plate, no colonies

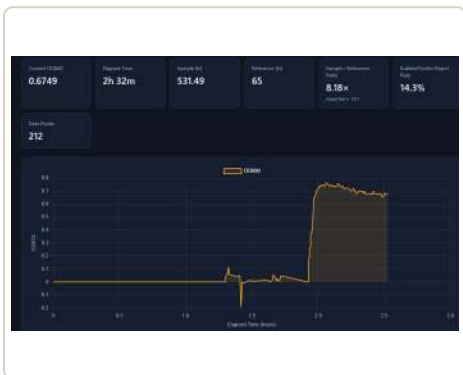
- **Found the flow cuvette cannot be cleaned while it is inline, so the blank was taken through a dirty window.**

The dashboard trace of the first in-line reading

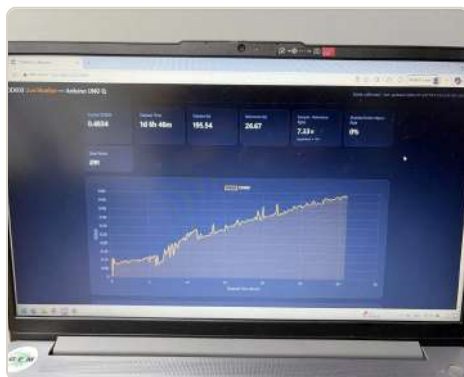
Dashboard at 1 d 6 h 46 m, 291 points: OD600 0.4834, ratio 7.33x

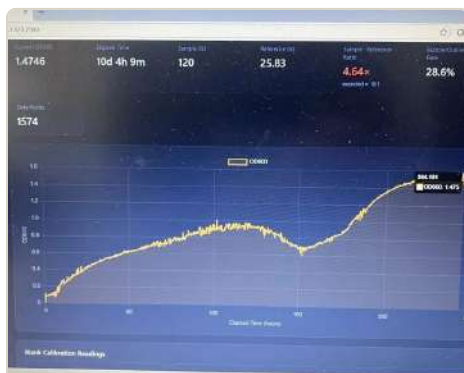
10 d 4 h: rejection 28.6 %, ratio 4.64x shown in red

- **Found the recirculation pump had failed. Chars confirmed on inspection and replaced it the same evening.**
  - Nobody was rostered to check the trace daily, which is why the drop was noticed late.
- **Did not run the flush and reblank that would have separated fouling from biology.**
  - Once the run was torn down the chance was gone.

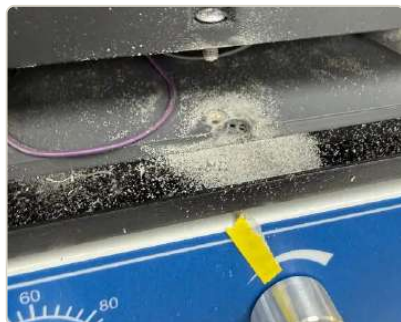
- The shaker frequency was likely too high for the print. The post failed where it joins the plate.

The housing on the shaker: debris around a torn hole in the bottom plate

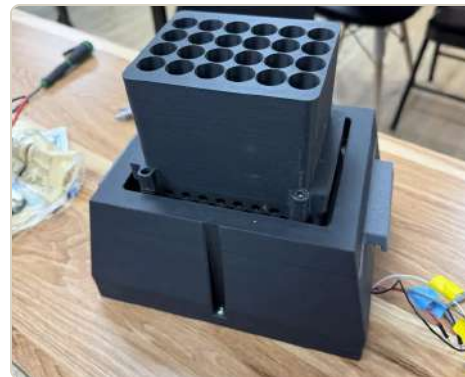
Final: the black tube holder seated on the housing

- **Used all four screw positions, up from two, and reinforced every solder joint.**
- **Printed the tube holder in black and raised its walls from 2 loops to 4.**
  - That is the fix for the light leaking between wells.

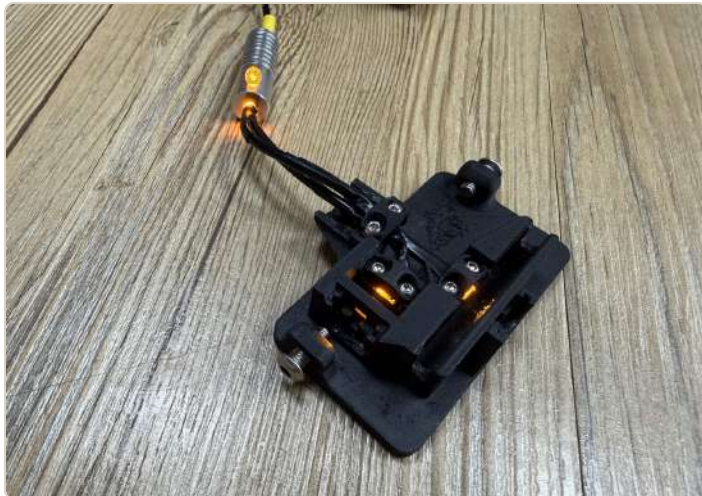
12 October: the newer photometer, light almost against the cuvette
